EARTHQUAKE RESISTANCE OF REINFORCED CONCRETE CORNER BEAM-COLUMN JOINTS WITH DIFFERENT COLUMN AXIAL LOADS UNDER BI-DIRECTIONAL LATERAL LOADING

Kazuhiro Kitayama¹ and Hiromu Katae²

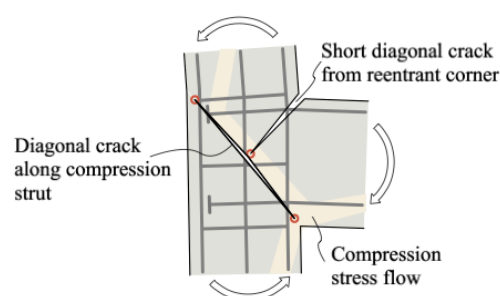
Figure 1: Joint hinging model for an exterior joint [2].

A new mechanism of joint hinging was proposed by Shiohara [1], a professor at the University of Tokyo, Japan, for a beam-column joint in reinforced concrete (RC) moment-resisting frames. The joint hinging mechanism is observed in laboratory tests when an ultimate flexural capacity of a column section is close to that of a beam section in an RC unit frame. A joint hinging model proposed by Kusuhara and Shiohara [2] is shown in Figure 1 for a plane exterior beam-column joint. An exterior beam-column subassemblage is divided into three elements; an upper column, a lower column and a beam. Each element rotates like a rigid body as shown in Figure 1, forming a principal diagonal crack along a diagonal compression strut in a joint and a short diagonal crack developing from a reentrant corner in a tension side.

Crack patterns and damage conditions on the south surface of the joint are shown in Figure 7 at story drift angles of 1 % and 2 %. Flexural cracks occurred at beam critical sections for the two specimens at a story drift angle of 0.2 %. Principal diagonal cracks occurred in the beam-column joint, and beam longitudinal bars and joint lateral hoops yielded during a loading cycle with a story drift angle of 1 % for both specimens. Column longitudinal bars yielded at a story drift angle of 0.9 % for Specimen K2 with a column axial stress ratio of 0.04 and 1.5 % for Specimen K3 with a column axial stress ratio of 0.12. Almost all longitudinal bars in the beams and column yielded at both the vertical or horizontal critical section and a point crossing a short diagonal crack which developed from a reentrant corner shown in Figure 1.

Compressive stress induced in the concrete of a corner beam-column subassembly flows as shown in Figure 1. Compressive force from the upper column goes towards anchorage plates of beam longitudinal bars in the joint, and the direction of the force changes at the anchorage plates due to a horizontal compressive reaction derived from beam bar tensile force, forming a diagonal compressive strut in the joint concrete. Thus the beam bar tensile force is carried to the joint concrete through both bond action along beam bars and bearing compressive action of anchorage plates placed at the end of beam bars. Beam bar tensile force (indicated by open squares), bond force (solid circles) and bearing compressive force at anchorage plates (solid diamond-shapes) are shown with a story drift angle in Figure 13 at loading point A during uni-directional loading in Figure 6 (a). The beam bar tensile force was obtained from measured strain at the column face in Figure 13 (c). Bearing compressive force at anchorage plates was regarded as equal to beam bar tensile force at the nearest strain-measuring point to the plate. Bond force along a beam bar was taken as a difference between the beam bar tensile force and the bearing compressive force.

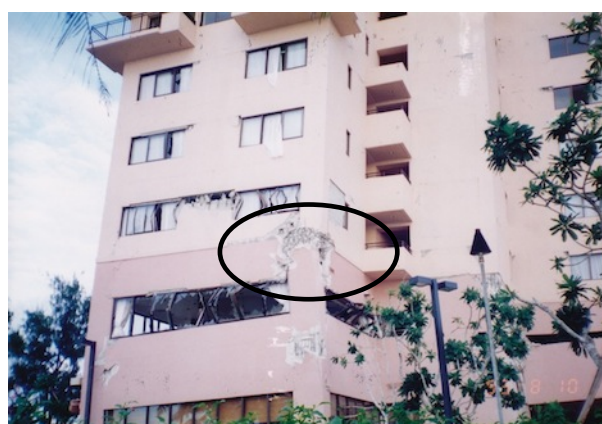
Figure 2: Failure of corner beam-column joint in Guam Island Earthquake in 1993.

Recent experimental studies to verify the joint hinging mechanism have been conducted using 2D plane interior [3] and exterior [4] beam-column subassemblage specimens. There are, however, few tests which use 3D beam-column-joint subassemblages with orthogonal beams to each other which frame into a column such as a corner beam-column joint [5]. The previous study [5] dealt with not joint hinging failure, but beam flexural yielding. For corner columns in RC buildings, a loss of capacity to sustain column axial load resulting from severe damage to a corner joint has resulted in partial story collapse of the buildings in past earthquakes as illustrated in Figure 2 for the 1993 Guam Island Earthquake. The ultimate flexural capacity of a corner column frequently decreases during an earthquake because the axial load on the corner column cyclically increases and decreases by change of direction of lateral loads induced by earthquake excitations. Therefore, it is of great importance to investigate earthquake resistant performance of a corner beam-column joint subjected to tri-directional earthquake loading.

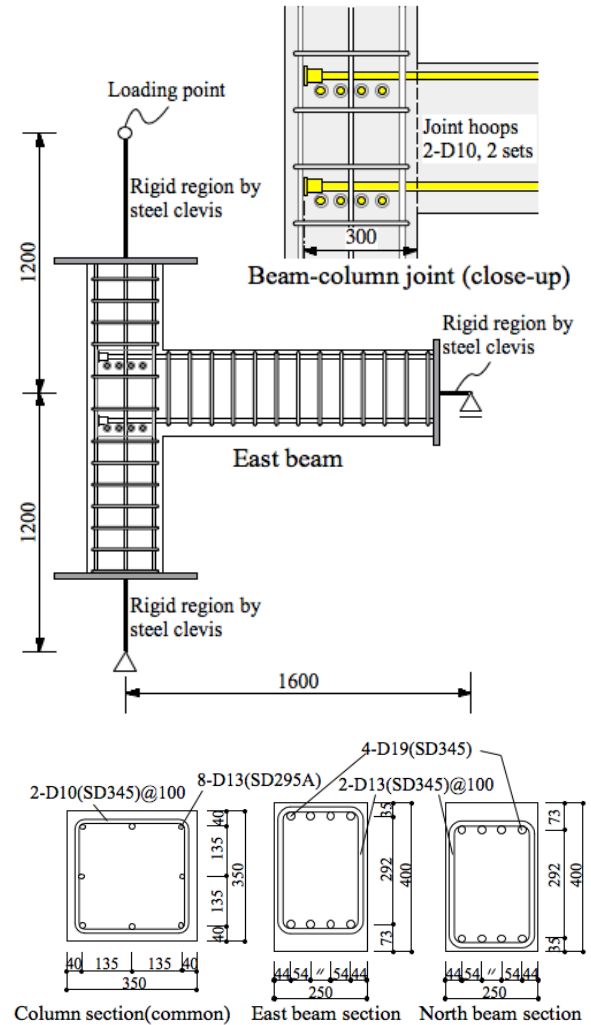
Figure 3: Details of specimens.

Two half-scale 3D corner beam-column subassembly specimens without slabs, removed from a 3D frame by cutting off the beams and columns at arbitrarily assumed inflection points, were tested. A configuration of specimens, section dimensions and reinforcement details are shown in Figure 3. Properties of specimens and material properties of concrete and steel are listed in Table 1 and 2 respectively. The length from a center of the column to a support of the beam end was 1600 mm. The height from a center of the beam to the loading point at the top of the column or to the bottom support was 1200 mm respectively.

Section dimensions and reinforcement arrangement for beams and columns were consistent in the two specimens. The column had a square cross section of 350 mm width with longitudinal bars consisting of 8-D13(SD295A) and hoops of 2-D10(SD345) at a center-to-center spacing of 100 mm. The beam had width of 250 mm and depth of 400 mm with longitudinal bars consisting of 4-D19(SD345) at the top and bottom of the section and stirrups of 2-D13(SD345) at a center-to-center spacing of 100 mm. A ratio of the total amount of column longitudinal bars to a column gross sectional area was 0.83 %, and a joint-hoop-ratio was 0.28 %, which almost corresponded to the lower bound required by Japanese Building Standard Law or seismic provisions. Beam longitudinal reinforcement was mechanically anchored by an end plate, using a headed bar, within the joint core concrete with a horizontally projected length of 300 mm corresponding to 0.86 times the column depth. Concrete compressive strength was approximately 50 N/mm².

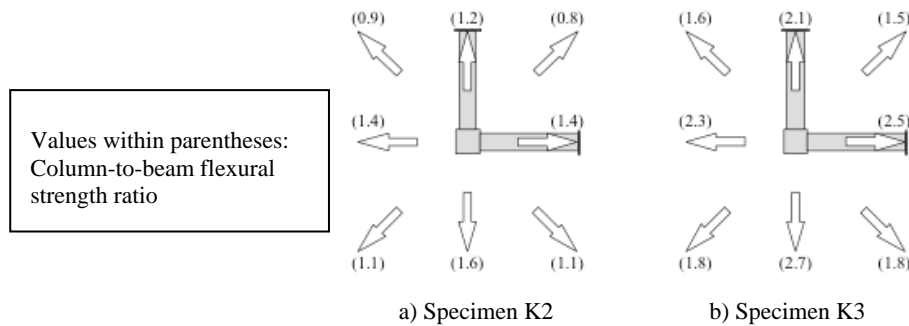
Figure 4: Column-to-beam flexural strength ratio under loading direction pointed by arrows.

The magnitude of column compressive axial load was chosen as a test parameter; e.g., 260 kN corresponding to a column axial stress ratio of 0.04 for Specimen K2 and 770 kN corresponding to the ratio of 0.12 for Specimen K3. The change in column flexural strength was achieved by changing the magnitude of column compressive axial load. Here, the column-to-beam flexural strength ratio indicated in Table 1 was defined as a ratio of ultimate flexural strength of a column section to that of a beam section, which were computed by section analyses assuming that plane sections remain plane. The column-to-beam flexural strength ratio for specimens varied depending on the direction of lateral load due to the asymmetrical position of beam bars in a beam section and varying axial load in a lower column which was caused by change of a direction of beam shear force. Thus, the column-to-beam flexural strength ratio ranged from 0.8 to 1.6 for Specimen K2 and from 1.5 to 2.7 for Specimen K3 as shown in Figure 4; where, the column-to-beam flexural strength ratio under bi-directional loading was computed on the assumption that a surface of ultimate flexural strength of a column is circular, and beam ultimate flexural strength is taken as resultant flexural strength of two orthogonal beams. Figure 4 shows column-to-beam flexural strength ratios under eight loading directions, as pointed by arrows, at a top of the upper column. Hereafter, a column-to-beam flexural strength ratio of 1.4 for Specimen K2 and 2.3 for Specimen K3 under uni-directional loading towards the west direction is used respectively as a typical value of the ratio in the paper.

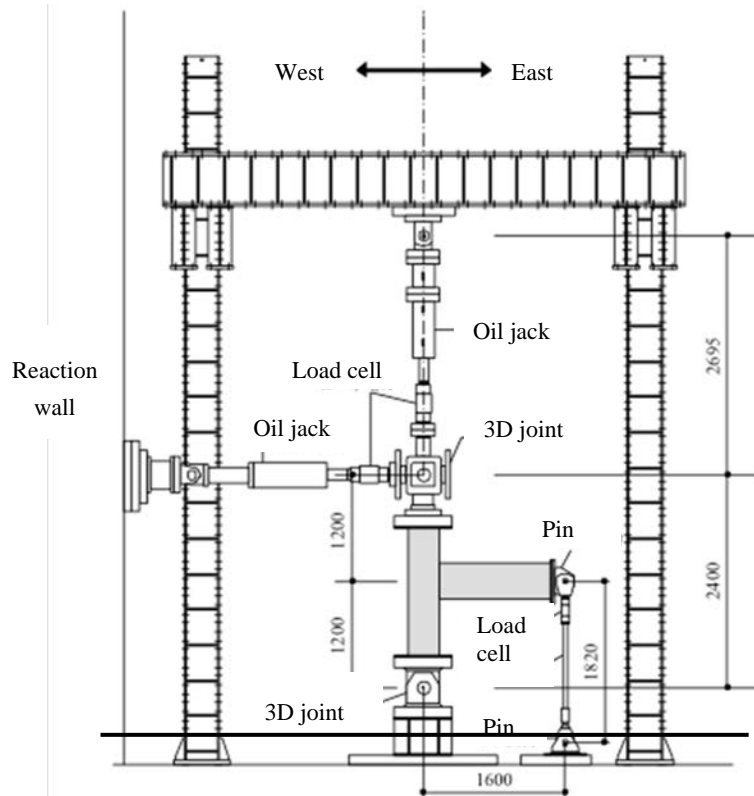
Figure 5: Loading apparatus.

The loading apparatus in the south elevation is shown in Figure 5. The east elevation was almost same as Figure 5. Beam ends were supported by horizontal rollers, while a bottom of the column was supported by a universal joint. The reversed cyclic horizontal load and the constant axial load were applied at the top of the column through a tri-directional joint by three oil jacks. Rotation around a vertical axis in the column was prevented by a steel pantagraph placed in a horizontal plane. Specimens were controlled by a story drift angle for loading cycles of 0.25 %, 0.5 %, 1 %, 1.5 %, 2 %, 3 % and 4 %. The story drift angle was defined as a story drift divided by a height of the column, 2400 mm.

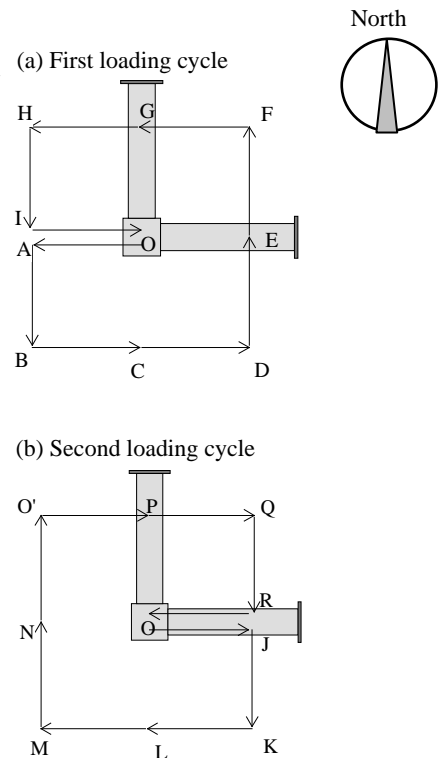
Figure 6: Loading paths at top of column.

Loading paths at the top of the column under bi-directional lateral load reversals are shown in Figure 6. The top of the column moves in a square path in the horizontal plane. For the first loading cycle, after a prescribed drift was given to the top of the column from the origin point O to point A in Figure 6 (a), the loading path was defined by a counterclockwise square from points A to I, and finally the column top was loaded back to the origin point O. For the second loading cycle, the loading path was a clockwise square from points J to R in Figure 6 (b). For all bi-directional lateral loading cycles, uni-directional lateral load was applied until the prescribed drift was achieved in one direction, then, holding the drift constant in that direction, loading was applied in the other direction.

Widths of a principal diagonal crack along a main compression strut in a joint are shown in Figure 11. The widths were measured by a crack-gauge under bi-directional loading at a story drift angle of 2% located at both loading point F and point G at an EW directional story drift of zero as shown in Figure 6 (a). Note that a NS directional story drift was kept constant for loading from point F to G, sustaining some story shear force in the north-south direction. Locations where crack widths were measured are shown in Figure 12; a principal diagonal crack crosses a center axis of the column at point "a" and crosses another diagonal crack generated by a reversed loading at point "b".

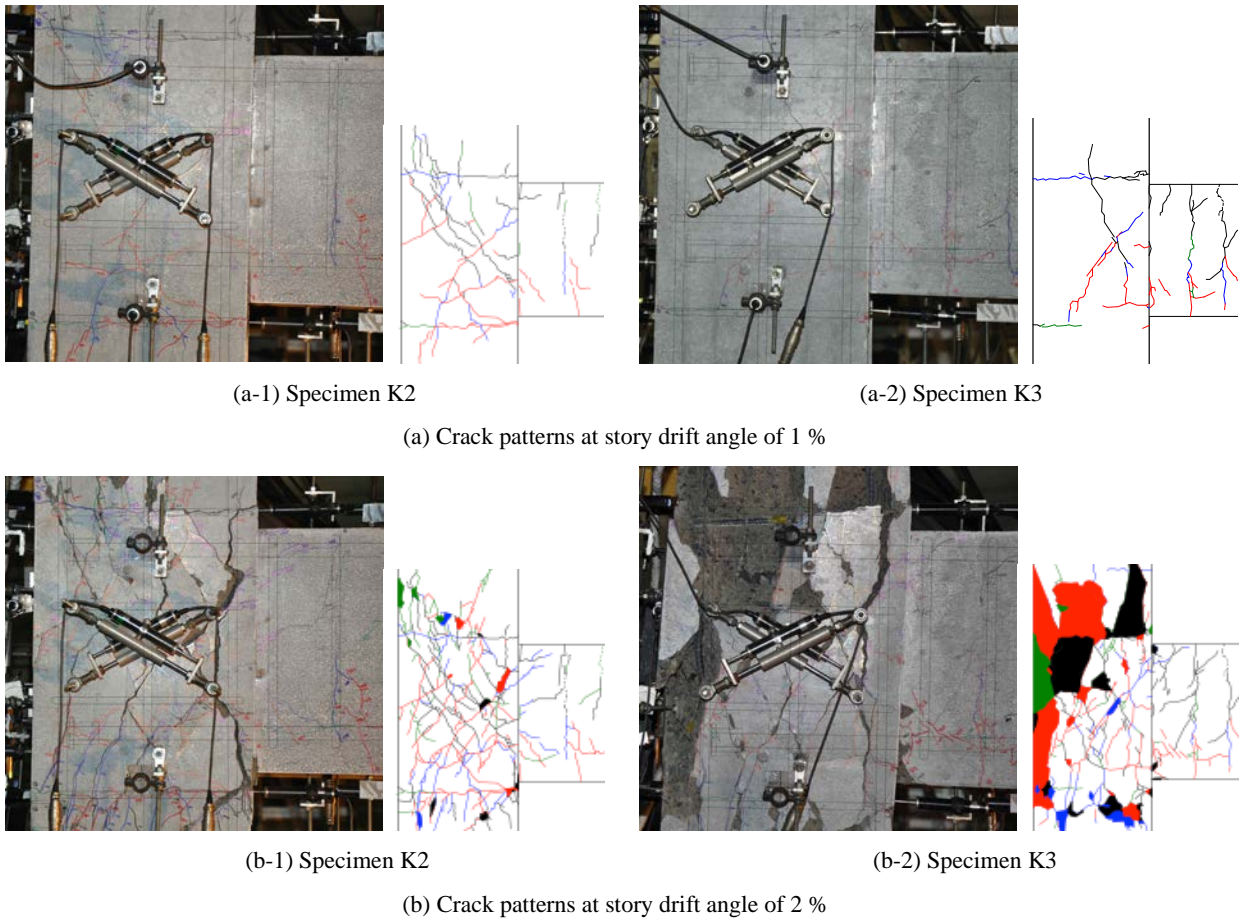
Figure 7: Crack patterns and damage conditions.

Damage in a joint panel for Specimen K3 with a column axial stress ratio of 0.12 was mitigated up to a story drift angle of 1.5 % compared to Specimen K2 with a column axial stress ratio of 0.04, but progressed abruptly during a loading cycle with a story drift angle of 2 %. Core concrete in the joint region spalled off, and column longitudinal bars buckled within the joint at a story drift angle of 3 % for Specimen K2 and 2 % for Specimen K3. Column bar buckling was caused by concrete crushing in the beam-column joint core and inferior confining action due to the small number of joint lateral hoops and column longitudinal bars.

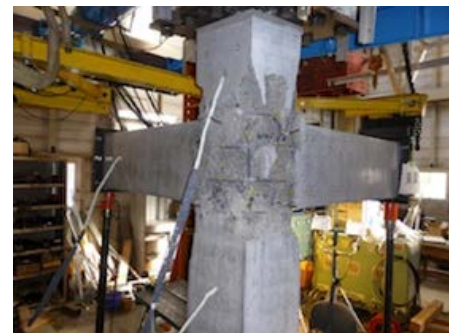
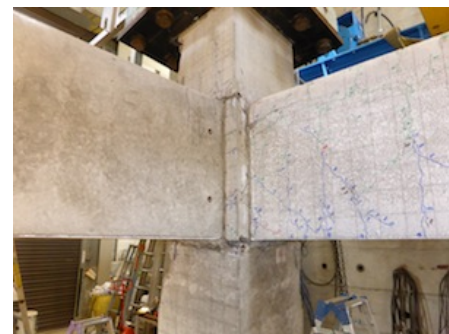
(a) Outer surface

(b) Inner surface

Figure 8: Damage conditions for Specimen K3.

Damage in a beam-column joint surface without framing beams was heavier than that with framing beams as shown in Figure 8. This indicates that beams framing into a joint panel contributed to mitigating damage to the joint due to its confining action.

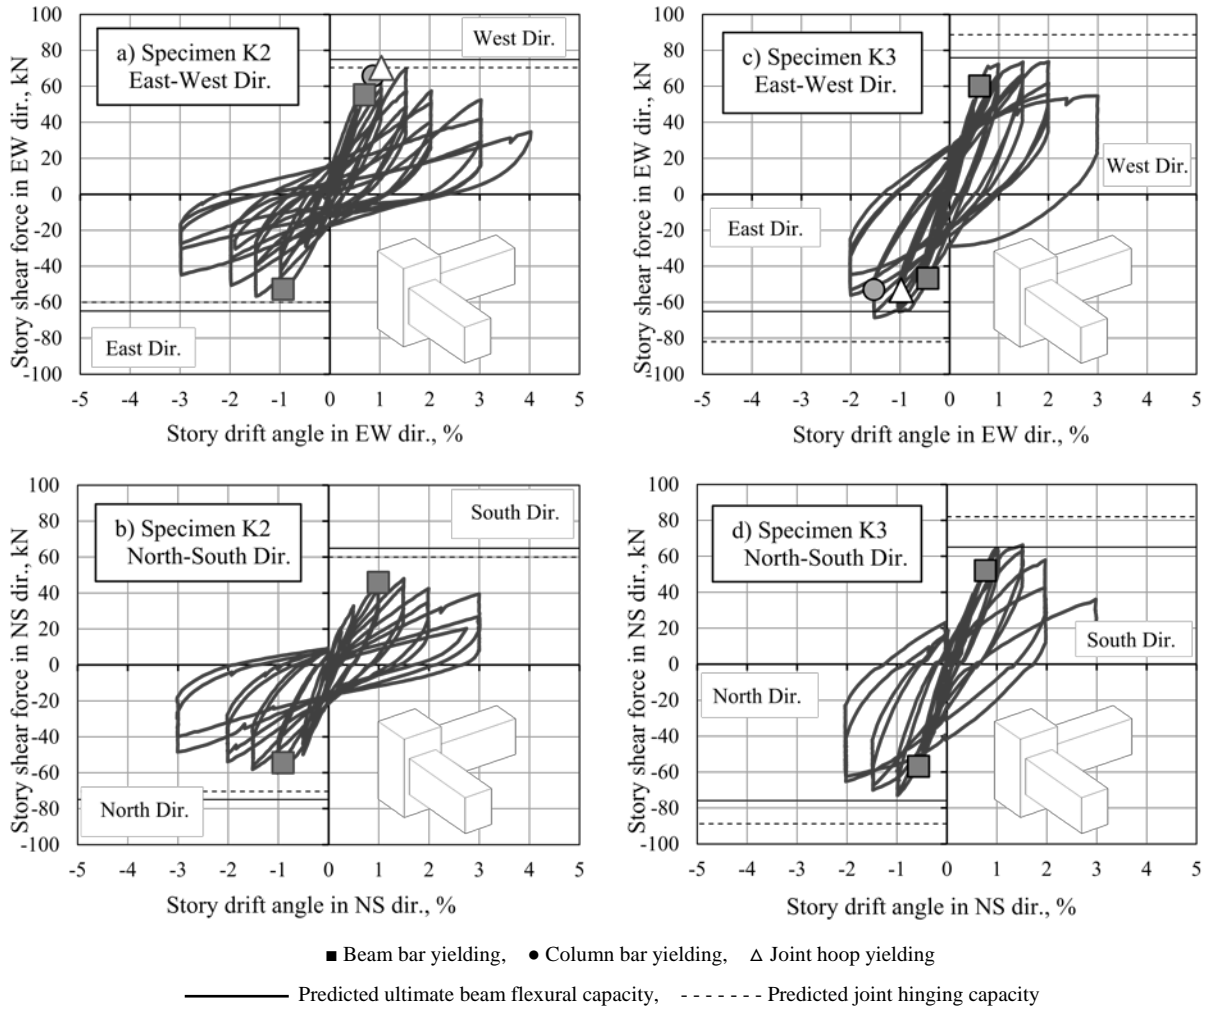
Figure 9: Story shear force - story drift angle relations.

The story shear force - story drift relations are shown in Figure 9 in the east-west and north-south directions. The story shear force was computed from moment equilibrium between the measured beam shear force and the horizontal force at the loading point at the top of the column. Peak story shear forces and story drift angles when reaching the peak story shear force obtained by the tests are summarized in Table 3 along with predicted ultimate capacities of the beam and joint. The ultimate beam flexural capacity, computed by a section analysis assuming that plane sections remain plane, is indicated by a horizontal solid line in Figure 9. The joint hinging capacity was evaluated according to a proposed method by Kusahara and Shiohara [2] based on the failure mechanics in a beam-column joint shown in Figure 1, indicated by a horizontal dotted line in Figure 9 and Table 1. The joint hinging capacity is computed by using the column-to-beam flexural strength ratio, the amount and yield strength of joint lateral hoops and beam longitudinal bars, concrete compressive strength and an aspect ratio of the joint region.

Hysteresis loops exhibited a little pinching shape for Specimen K2 with a column axial stress ratio of 0.04 (a column-to-beam flexural strength ratio of 1.4). In contrast, those showed a fat spindle shape for Specimen K3 with a

column axial stress ratio of 0.12 (a column-to-beam strength ratio of 2.3), showing a larger amount of energy dissipation. This was caused by restraint of diagonal crack opening in a joint due to large column axial load in Specimen K3.

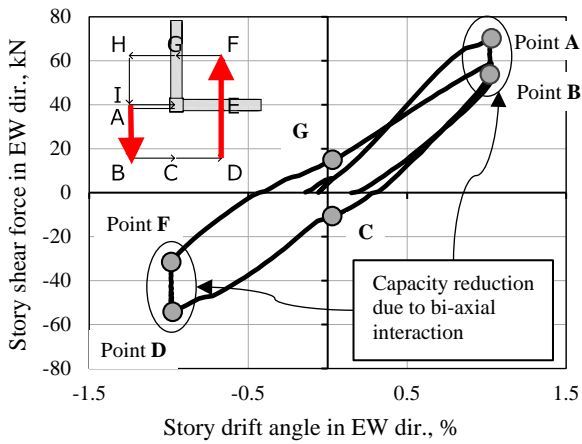
Figure 10: Hysteresis loop in EW direction during first loading cycle at story drift angle of 1% (Specimen K2).

One hysteresis loop in the east-west direction during a first loading cycle at a story drift angle of 1 % is highlighted in Figure 10 for Specimen K2. From loading point A to B, and D to F, lateral load was simultaneously applied in the north-south direction, while story drift in the east-west direction was kept constant, i.e., a story drift angle of 1 %. Lateral shear

force descended from loading point A to B, and D to F due to bi-axial interaction for joint hinging resistance.

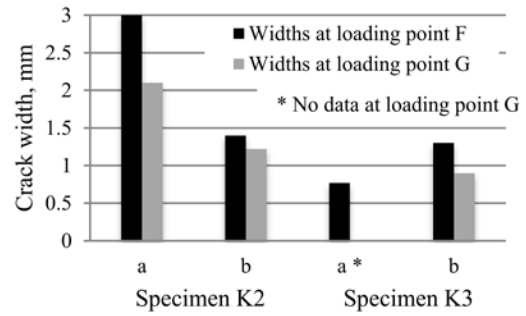
Figure 11: Principal diagonal crack widths in joint.

The maximum crack width for Specimen K3 was 0.75 mm at loading point F subjected to peak story shear force in the east-west direction at the measurement point "a", which was one-quarter that of 3 mm for Specimen K2. Crack widths measured for Specimen K3 were consistently smaller than crack widths measured for Specimen K2 for a range of loading points. This

confinement of crack opening is attributed to compressive axial load to the column in Specimen K3 which was three times as large as that in Specimen K2.

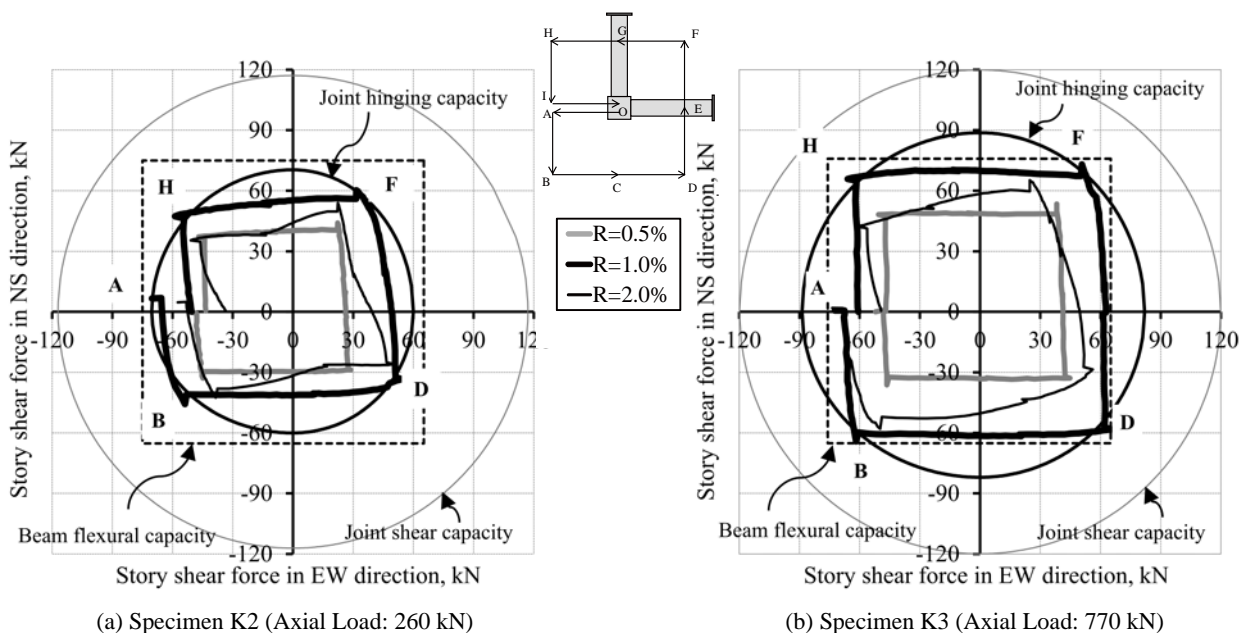
Figure 14: Orbit of story shear resistance under bi-directional loading.

The orbit of the story shear resistance under bi-directional lateral loading in the first loading cycle is shown in Figure 14 at a story drift angle of 0.5 % before the occurrence of diagonal cracks in a joint, 1 % at diagonal cracking in a joint and 2 % at concrete crushing in a joint. The ultimate beam flexural capacity, the joint shear capacity, and the joint hinging capacity each predicted by aforementioned methods are also shown in Figure 14. The ultimate flexural capacity of a beam is illustrated by a rectangular surface by broken lines in Figure 14, while the joint shear or joint hinging capacities are indicated by circular or elliptical surfaces respectively. All the orbits of a story shear resistance under bi-directional loading remained inside a circle of the predicted joint shear capacity for both specimens. This indicates that a beam-column joint did not fail in shear.

The orbit of a story shear resistance for Specimen K2 depicted a rectangle under bi-directional loading at a story drift angle of 0.5 % since little damage occurred in a beam-column joint. The orbit, however, changed to a curved line at a story drift angle of 1 % because of joint damage. Then four peak points under bi-directional loading, i.e., points B, D, F and H in Figure 14 (a), were located on the elliptical line of the predicted joint hinging capacity.

The orbit of the story shear resistance for Specimen K3 with a column axial load three times as large as Specimen K2, depicted a rectangular surface under bi-directional loading up to a story drift angle of 1 % (as indicated in Figure 14 (b)) since the joint concrete suffered only slight damage. Peak story shear capacities, especially at loading points B and D in Figure 14 (b), almost reached both the ultimate beam flexural capacity and the joint hinging capacity. Specimen K3 behaved dominantly in beam flexure and then reached the peak capacity because damage was slight in a beam-column joint at a story drift angle of 1 %. Just before loading point F at a story drift angle of 1 %, however, the story shear capacity in the east-west direction decreased due to the onset of joint hinging failure, which was attributed to reduction of axial load in the lower column at loading point F induced by vertical shear forces in both beams. After loading point F, damage to the joint grew rapidly with the continued increase in story drift and the story shear resistance descended. Thus the orbit of a story shear resistance at a story drift angle of 2 % depicted curved lines and was located within the elliptical orbit at a story drift angle of 1 % for Specimen K3.

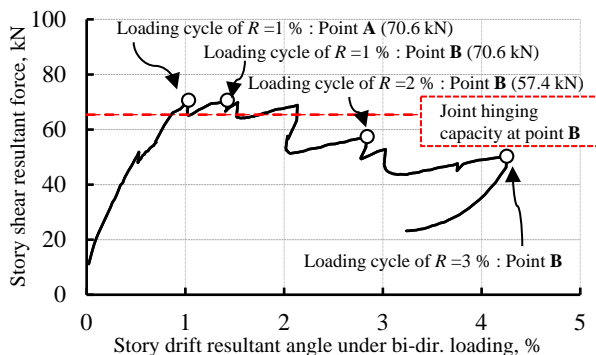
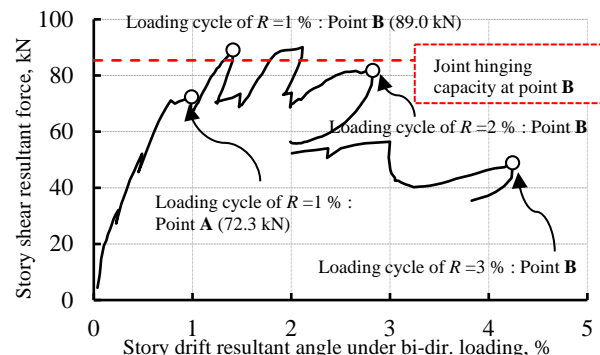
(a) Specimen K2 (Axial Load: 260 kN)

(b) Specimen K3 (Axial Load: 770 kN)

Figure 15: Story shear resultant force under bi-directional loading.

Envelope curves of the relationship between the story shear resultant force and story drift resultant angle under bi-directional loading from the origin point O to loading point C (in the loading paths illustrated in Figure 6) are shown in Figure 15. The story shear resultant force or story drift resultant angle were obtained by the square root of sum of squares of story shear forces or story drift angles in EW and NS directions.

The story shear force at loading point A reached the peak value of 70.6 kN at a story drift angle of 1 % for Specimen K2. During bi-directional loading from loading point A to B, a story shear resultant force remained almost constant; 70.6 kN at loading point B in Figure 15 (a). This was caused because the beam-column joint started to fail in joint hinging at loading point A and the orbit of the story shear resistance under bi-directional loading depicted part of an ellipse as shown in Figure 14 (a).

In contrast, flexural yielding for Specimen K3 occurred in an east beam at a story drift angle of 0.8 % and stiffness was degraded as shown in Figure 15 (b). Under bi-directional loading from loading point A to B, a north beam yielded in flexure and the story shear resultant force increased to 89.0 kN at loading point B, which was 23 % larger than that at loading point A; 72.3 kN.

The peak story shear resultant force obtained at loading point B exceeded the predicted joint hinging capacity, shown by horizontal dashed lines in Figure 15, for both specimens; the former was 8 % or 4 % larger than the latter for Specimen K2 or K3 respectively. The story shear resultant force for Specimen K3 declined heavily due to progressive failure in the beam-column joint after a story drift resultant angle of 2.8 %, leading to axial collapse of the subassembly. This should be noted for seismic design of RC buildings when a small amount of column longitudinal bars and joint lateral hoops are provided according to the lower bound required by Japanese building law or seismic provisions.
